55-Gallon Drum in Walnut Creek Drainage

On Wednesday, December 11, 2024, the U.S. Department of Energy, Office of Legacy Management (LM) successfully removed the 55-gallon drum in the North Walnut Creek drainage following the procedures outlined in our email to CDPHE on November 21st. In addition to the screening measures outlined in our email, we also screened the drum using a photoionization detector (PID). There were no indications of any environmental impacts associated with the drum. The drum did not have a label affixed to it. However, we did find part of a label for "Trichloroethane" in the excavation. Trichloroethane is used as a solvent and degreaser, and is a highly volatile compound.

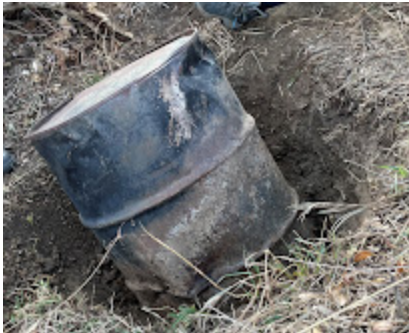
Drum Removal_1.jpg
1632K

2. To remove the drum, we:
 - a. Removed soil in 6-inch lifts and monitored the uncovered soils and the surface of the drum as they were exposed; no discoloration or staining of the soil was identified. Monitoring continued with the 4-gas meter and radiation detection instruments to verify acceptable conditions. The excavation was completed at less than 30 inches below ground. All readings were at background or non-detectable levels.

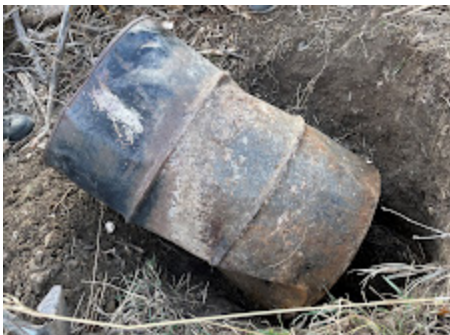
Drum Removal_2.jpg
2497K

3. After the drum was removed, we:
 - a. Visually inspected the excavation and did not identify any staining or discoloration.
 - b. Inspected the removed drum. It is dented and rusty with some holes. No labels, serial numbers or other markings were found on the drum. The decomposed remnants of a label with trichloroethane information was discovered in the bottom of the excavation. The label was removed from the excavation and bagged.
